Deluge and Drought: a Landscape Designed for Rainwater Management

November 15, 2018

by Julia Bunn

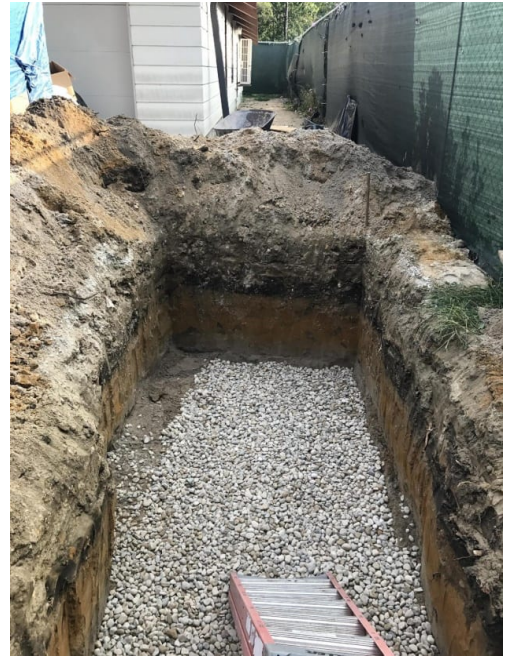
Excavation for the green infrastructure piece that drew the attention of city engineers. Put in place before grading began, its location was in an area that needed to take in over 1115 Gallons of water in a two-inch rain event from a downspout that is conveying roof runoff from an 808 sf area. A minimum of 404 sf would be needed to construct a rain garden, and we only had 120 sf of garden space available.

Now turning to the process, we ran into a problem early. The initial construction elevations were not based on the design we proposed, so when we began completing our grading in the fall of 2017, a City of Evanston engineer, who was unfamiliar with the Cultec infiltration system we were using in order to complete our goal of keeping all our water on-site, requested a stop work order. The city had not, prior to our installation, encountered using such a solution for a residential landscape and wanted a drawn plan of our intended changes for the grading that explained how the water would be managed in lieu of the original plan that simply used grading to send stormwater away from the house and toward the street storm water system.

gardens, swales, and rechargers in their projects. The soil horizon in the Cultec excavation clearly supported that the site soil conditions of a sandy gravel were ideal for infiltrating large quantities of water and indicated that the local water table was also well below where our client was building. The new grading drawing and support documentation were completed and accepted by the city before winter freeze hit, which made it possible to complete the majority of the grading work, plant most of the shrubs, and partially install the drip irrigation system. The planting of the perennial rain gardens would have to wait until spring 2018.

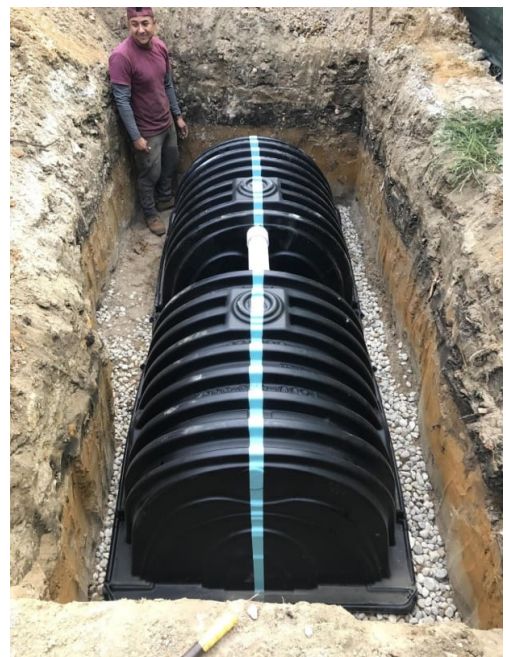
The two installed Cultec XLR330 rechargers manage, in a very small space, all of the water coming in from the roof.

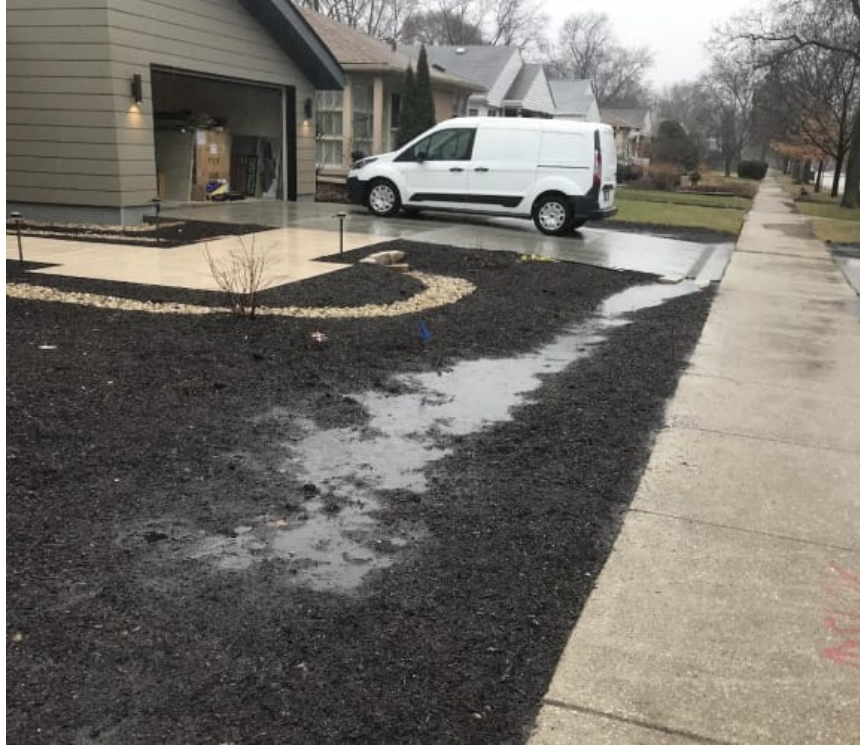
The incomplete swale coming off the channel drain of 510 sf of concrete driveway at the front of the property needed to be finished to manage the water as planned.

The new landscape experienced its first winter thaw and freeze cycle, and all water was managed in the way we expected. However, it was immediately apparent that we needed to finish the swale designed to manage the driveway water. It needed to be 256 sf at a nine-inch depth that also encouraged a conveyance slope into the end ponding area. Weather had cut short the completion of this detail, but it went to the top of the list for completing in the spring before we could plant.

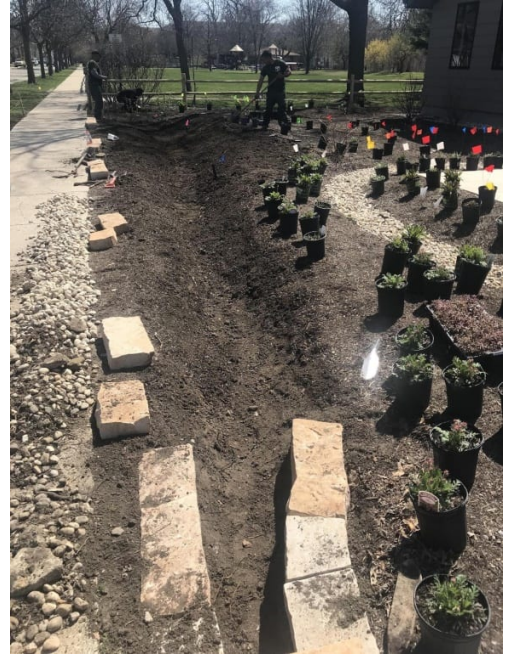
Delayed by weather, we finally were able to repair the swale in late April ahead of planting.

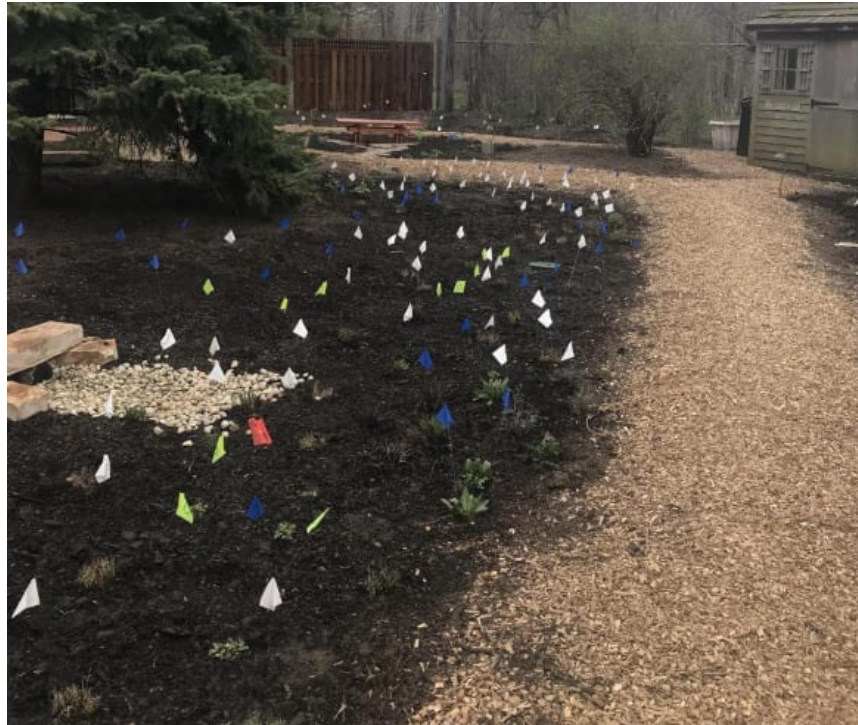
Using colored flags to mark plants, we monitored the beds for seasonal bloom. The bed shown here is in the back yard managing water off of the central roof that is conveyed via PVC pipe under the back patio to the garden.

The flagged bed shown above was initially planted with a cultivar of *Carex muskingumensis* 'Little Midge', which was a risky move because there was no known study of its ability to handle water the way its parent palm sedge did. My assumption that it would perform well based upon its lineage did not pan out. It basically failed. Later in the summer we changed to the native brome sedge (*Carex bromides*) as the design matrix sedge for this low field. It soon proved to be the resilient plant needed to do the job of managing the stormwater runoff from the house's center roof while keeping a low profile bed, which is still a work in progress. The Little Midge palm sedge failure sent me back to the drawing board. We will add marsh marigold (*Caltha palustris*) and more brome sedge next spring.

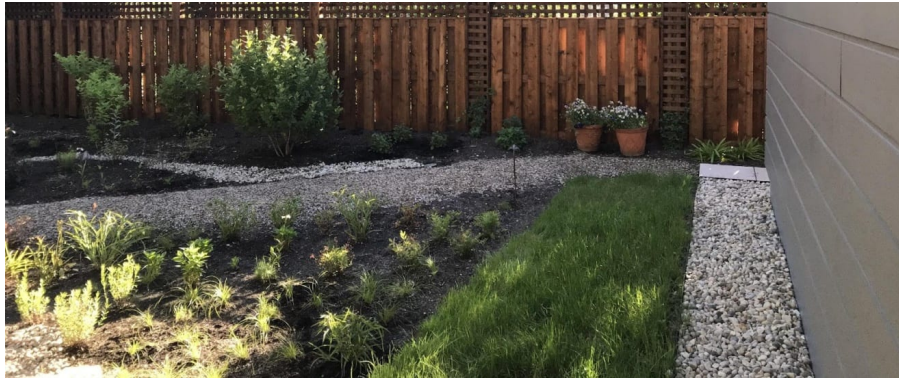
Here is the Low Sedge Rain Garden in July, before the coreopsis began to fail and after amending the plantings with the brome sedge to supplant the Little Midge palm sedge.

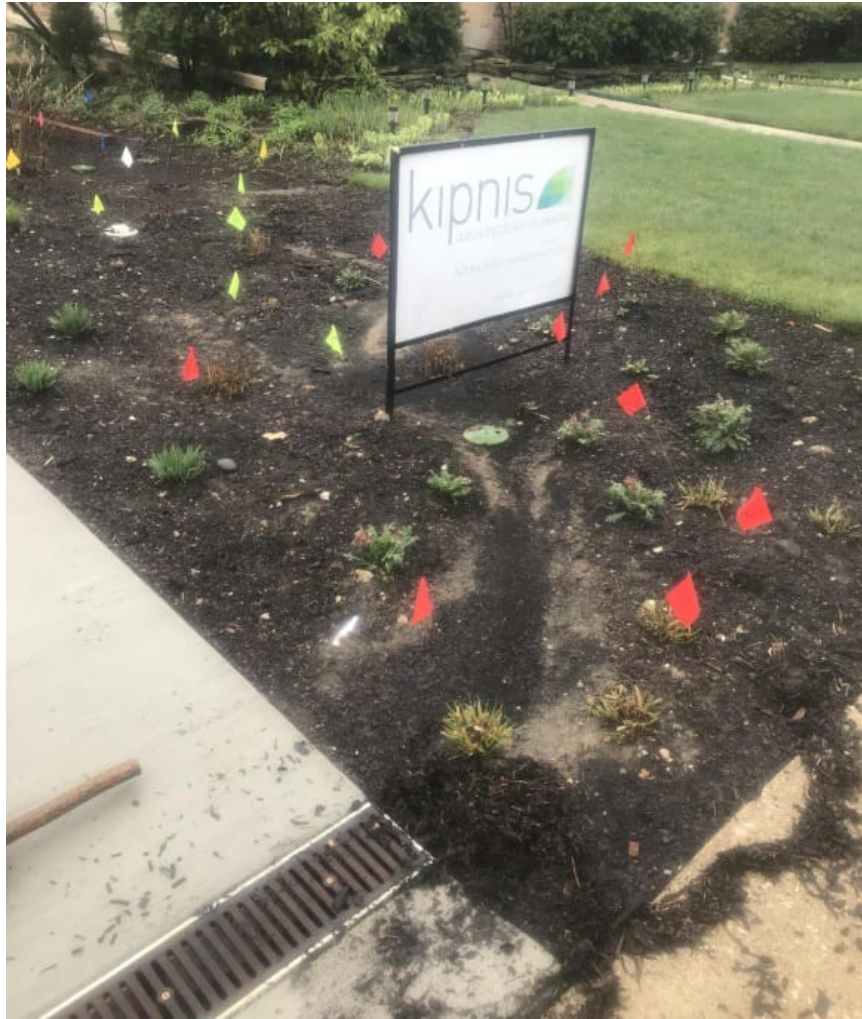
A neighbor's downspout (top left) produced an unexpected erosion problem that was quickly remedied.

The neighbor's downspout was pointing directly at our client's yard. With the kind cooperation of the neighbor, we made a quick and easy fix – simply extending her downspout and directing the water into the grass in front of her garden bed. Additionally, we deepened the ponding area around the pop-up from the Cultec tanks, which was where the neighbor's erosion path had gone before, just in case there was a return of the neighbor's downspout problem or an overflow from the tanks. To date there has been no overflow, and we experienced two three-inch rain events between February 19 and February 20.

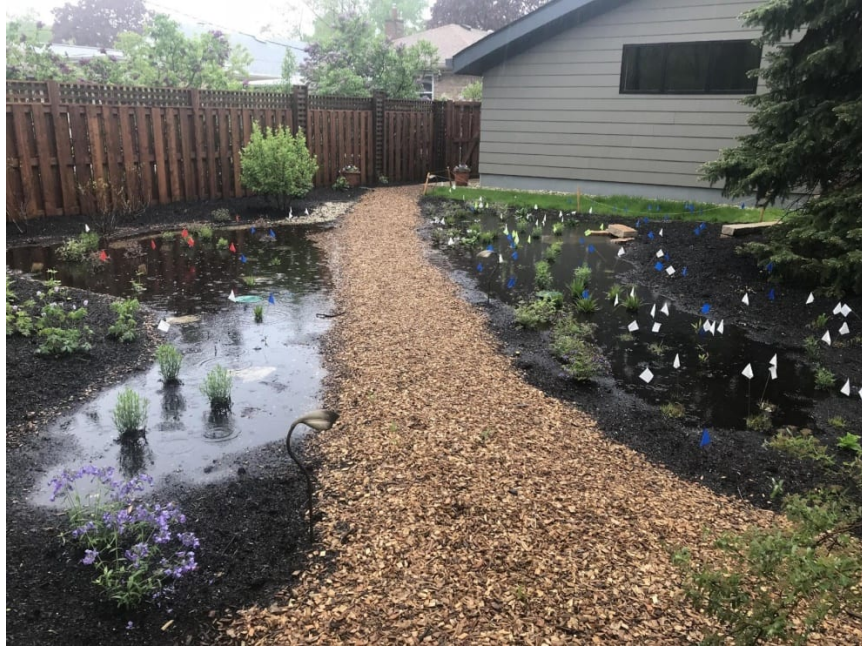
With most plants in place by May 2, the backyard rain gardens were put to work over several days of heavy rain in early May.

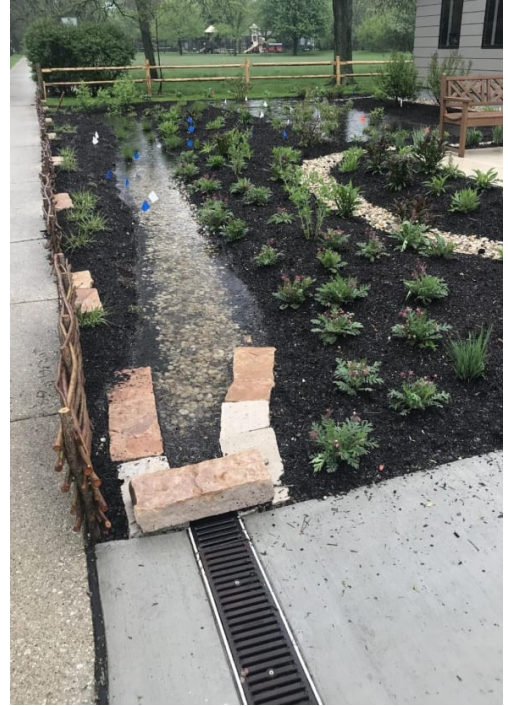
The front rain swale easily managed water produced in a two-inch rain event.

A two-inch rain event was registered with the National Rain Service on May 22nd. The front swale managed it handily!

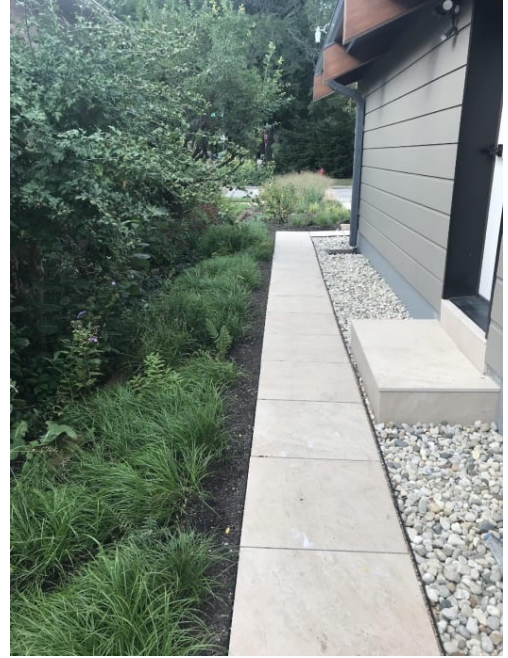
Side yard sedge/fern swale garden is working well in August.

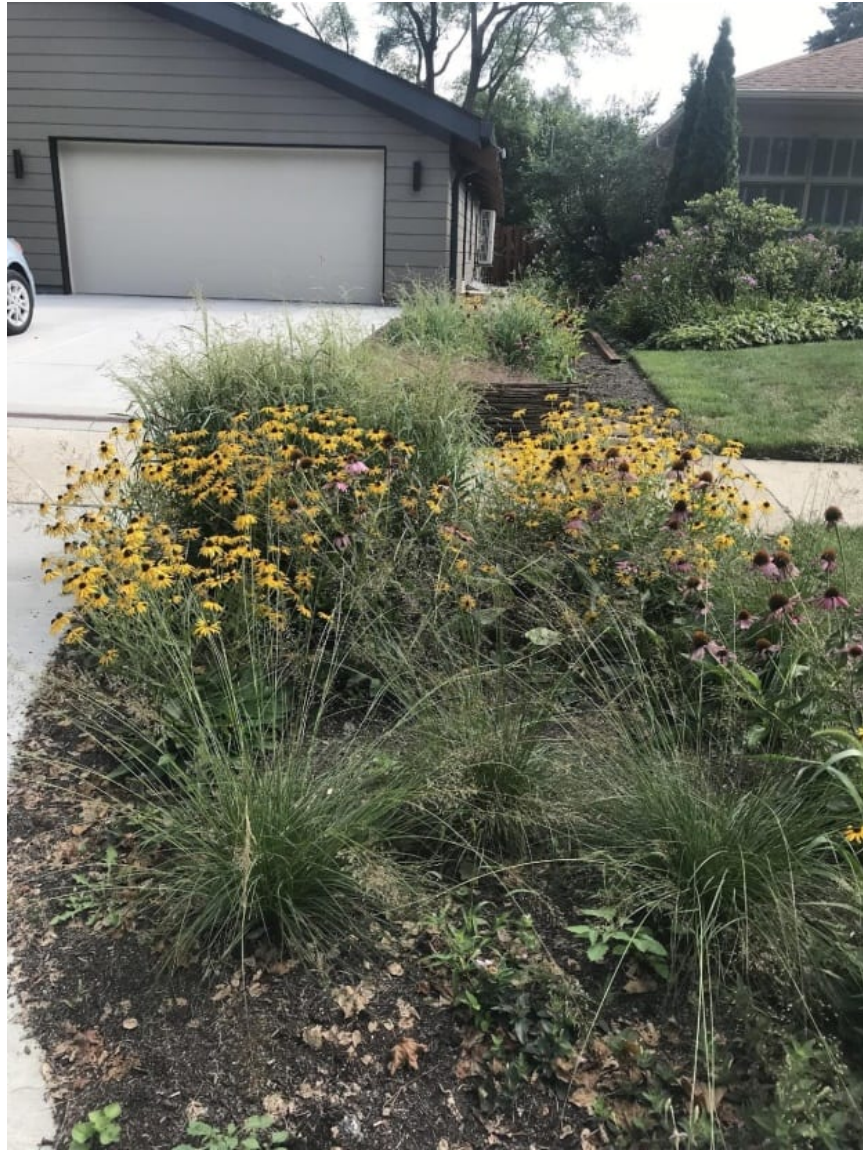
After drought conditions in July, the parkway garden looks great in August with minimal hand watering.

The parkway corner garden was not irrigated but hand watered when necessary. In this bed, prairie dropseed (*Sporobolus heterolepsis*), wild petunia (*Ruellia humilis*), purple cone flower (*Echinacea pupurea*) and black-eyed Susan (*Rudbeckia fulgida* 'Viette's Little Suzy) anchored the plantings, and bore testament to the resilience of natives and their cultivars.

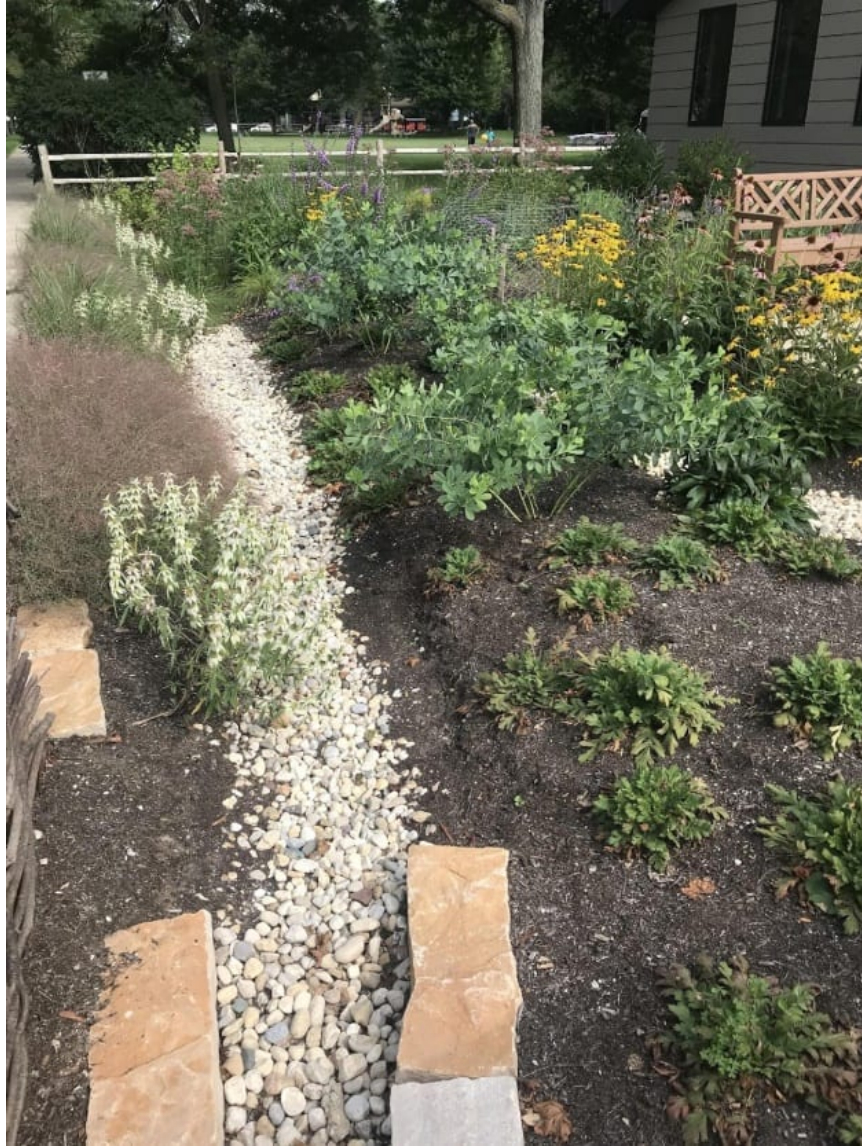
By the end of August, plants in the front yard swale start to fill in.

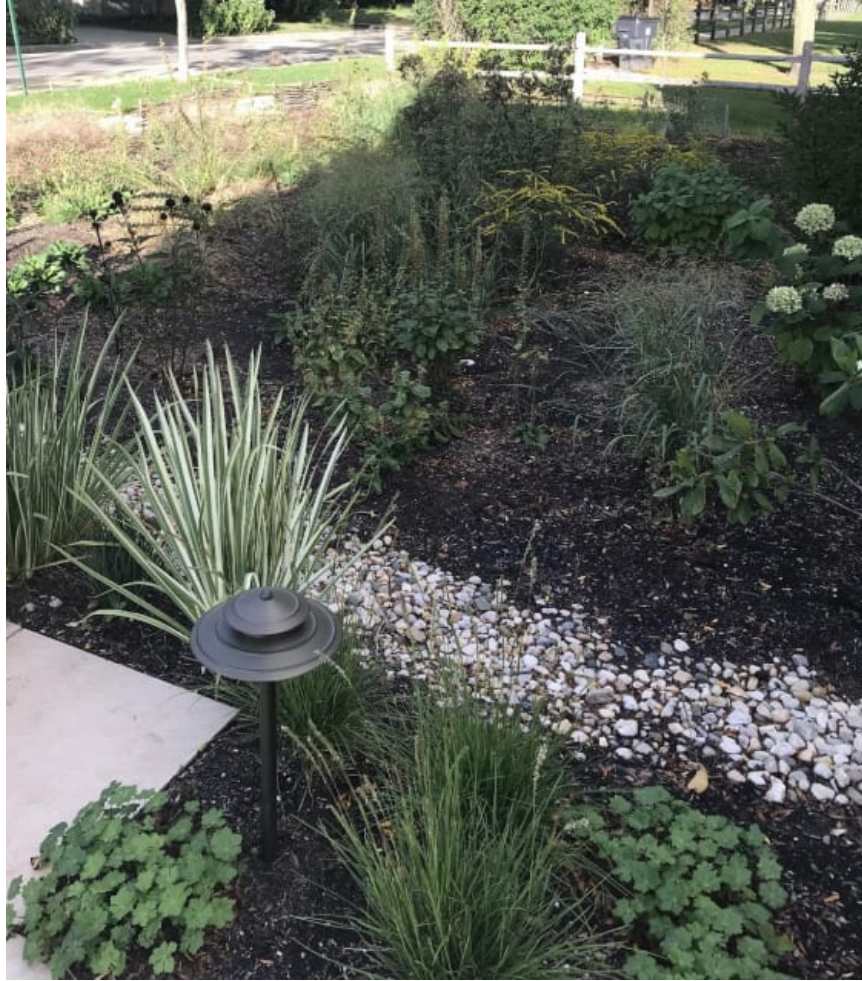
The front rain garden with goldenrod (*Solidago rugosa* 'Fireworks') shown in early October buzzed with pollinators still busily harvesting for the winter.
